Authors: Kristian C.E, Haller¹, Sara A.K., Andersson¹ and Hans Martinsen²

1. Acoustic Agree AB, Ronneby, Sweden

2. Ringhals AB, Väröbacka, Sweden

Title: Crack Detection in Cast Stainless Steel Valve Utilizing Nonlinear Acoustics

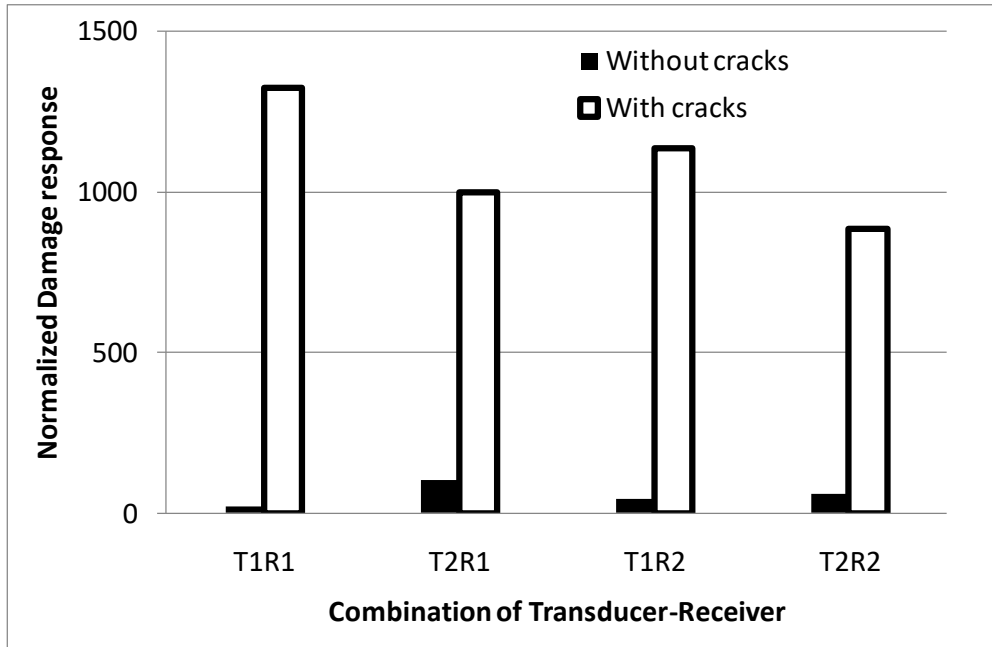
Figure 4, Fingerprint result for all transducer and receiver combinations.

The result produced utilizing the automatic method is shown in figure 4. The notation in the graphs follows the example T1R1, referring to the positions of the transducer (T1) and the receiver (R1). The graphs show the results for all the combinations of each transducer combined to each receiver. The bars filled with black are the results from the initial measurement, without the cracks introduced. The bars filled with white are the result from the measurement when cracks are introduced.

As can be seen, no matter which combination of transducer and receiver used for this measurement a clear indication of the presence of cracks is given. Introducing cracks into this valve gave at least 15 times larger indication value which is a clear indication of damage.

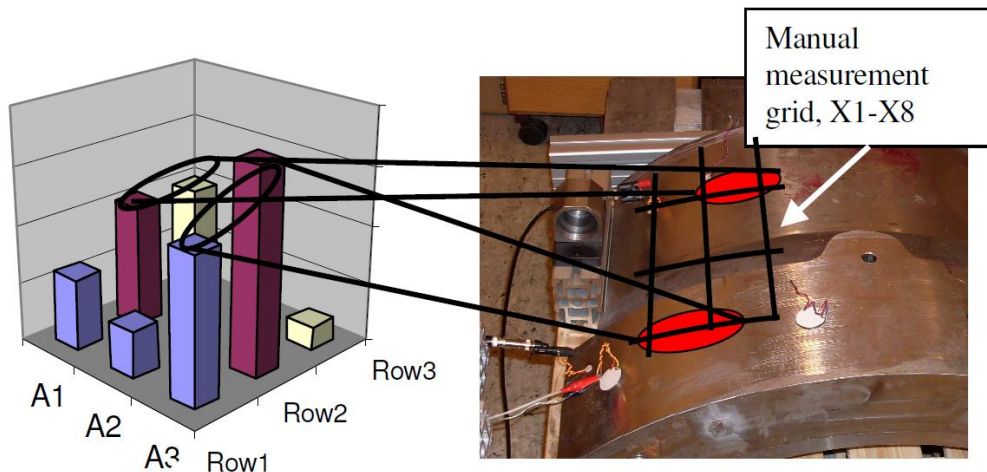
Figure 5, Localization of the damage.

The introduced damage consisted of two cracks in two different locations inside the valve. The cracks had the size of 50mm and 70mm respectively and were located in the middle of the valve's thickness. Both cracks were decided to be located in the right half of the valve as shown in figure 1 and in the left half as shown in figure 5. The locations in this half of the valve were unknown prior to this fingerprint measurement.

Using a manual technique all the transducer and receiver combination were obtained. By mapping the damage response in relation to each other in space, the physical location of the damage can be determined. This is presented in figure 5. The explanation legend is presented in table 1.

The graph to the left in figure 5 shows how the damage response is distributed in the valve after the cracks are introduced. The picture to the right in figure 5 shows where the damage is mapped from the damage response to the real valve. These locations were verified by Ringhals AB as being the correct positions.
