Authors: Kristian C.E, Haller¹, Sara A.K., Andersson¹ and Hans Martinsen²

1. Acoustic Agree AB, Ronneby, Sweden

2. Ringhals AB, Väröbacka, Sweden

Title: Crack Detection in Cast Stainless Steel Valve Utilizing Nonlinear Acoustics

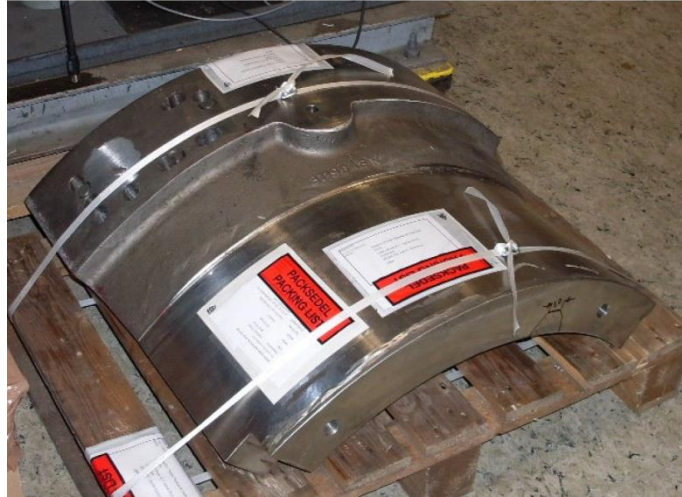
Figure 1, The 1/3 valve on pallet.

The introduced damage consisted of two cracks in two different locations inside the valve. The cracks had the size of 50mm and 70mm respectively and were located in the middle of the valve's thickness. Both cracks were decided to be located in the right half of the valve as shown in figure 1 and in the left half as shown in figure 5. The locations in this half of the valve were unknown prior to this fingerprint measurement.
